NOLTR 62-185

ACOUSTIC EFFECTS OF MARINE FOULING  
ON TRANSDUCERS

21 NOVEMBER 1962

UNITED STATES NAVAL ORDNANCE LABORATORY, WHITE OAK, MARYLAND

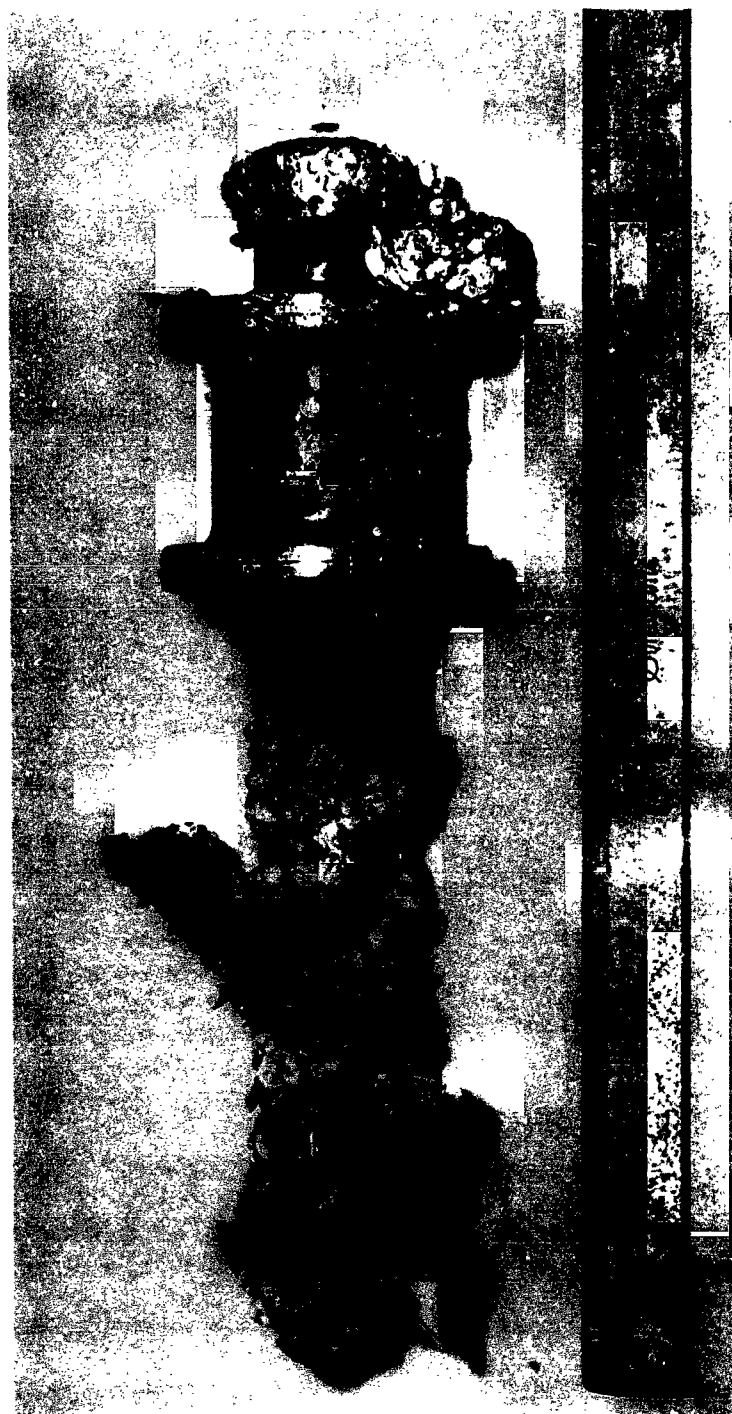
FIG. 1 A HYDROPHONE ON REMOVAL FROM IMMERSION FOR A PERIOD OF 13 MONTHS IN ST. ANDREW'S BAY, PANAMA CITY, FLA. THE LARGE SHELLS ARE OYSTERS, THE SMALL CIRCULAR SHELLS ARE BARNACLES. THIS PHOTOGRAPH IS INCLUDED TO SHOW AN EXTREME CONDITION OF FOULING; THE HYDROPHONE WAS NOT AMONG THOSE MEASURED FOR THIS REPORT.

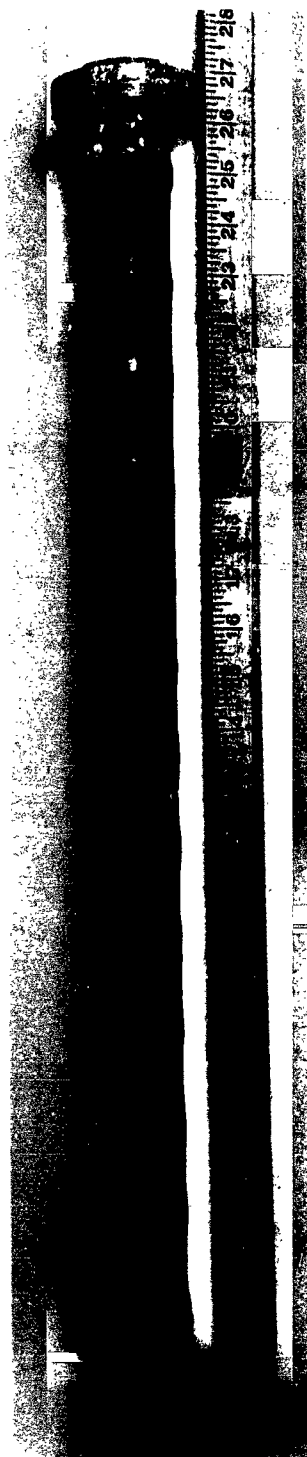
FIG. 3 MICROPHONE NO. 1 CLEANED

Description: Array of twelve cylindrical ceramic elements; overall length of the active portion 22 inches.

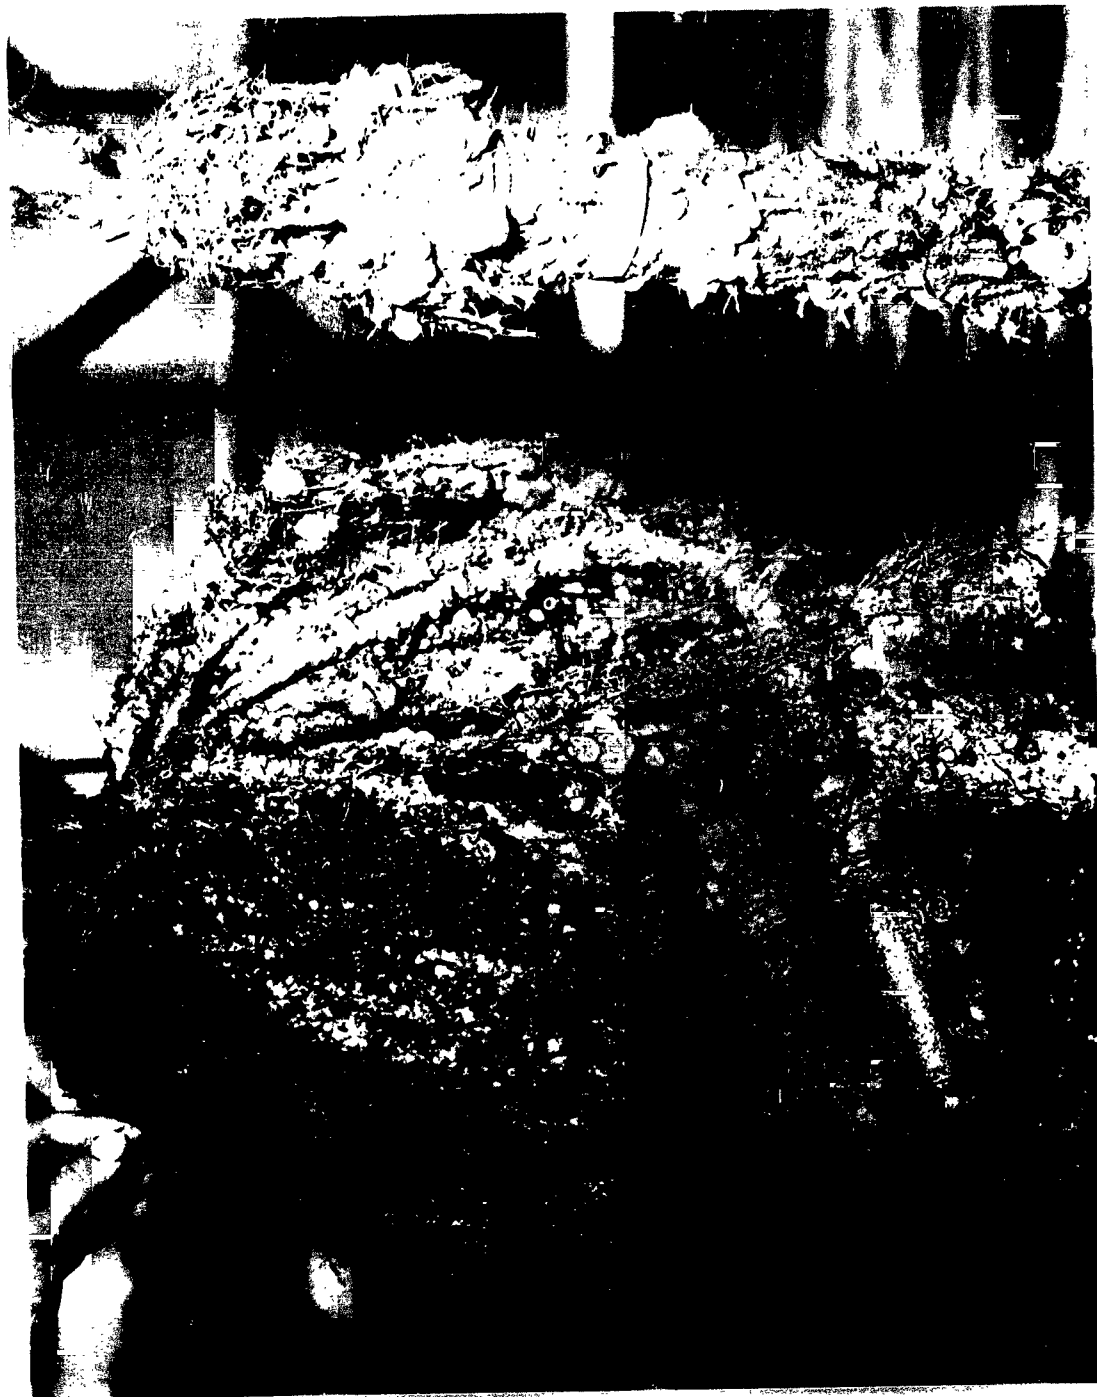
FIG. 7 HYDROPHONE NO. 2 (RIGHT HAND SIDE, PARTIALLY VISIBLE) AND HYDROPHONE  
NO. 4 (LEFT HAND SIDE, CLUSTER OF UNITS), FOULED.

Description of Fouling: 10% of the surface area was covered with barnacles, and 10% area was covered with hydroids (Bryozoans, sea squirts). Remainder of transducer face unfouled. Brass top cap, however, was completely fouled.

Description of Fouling: Unit was only slightly fouled. Approximately 10% of area was covered by barnacles, with a 5 - 15% covering of sea squirts.

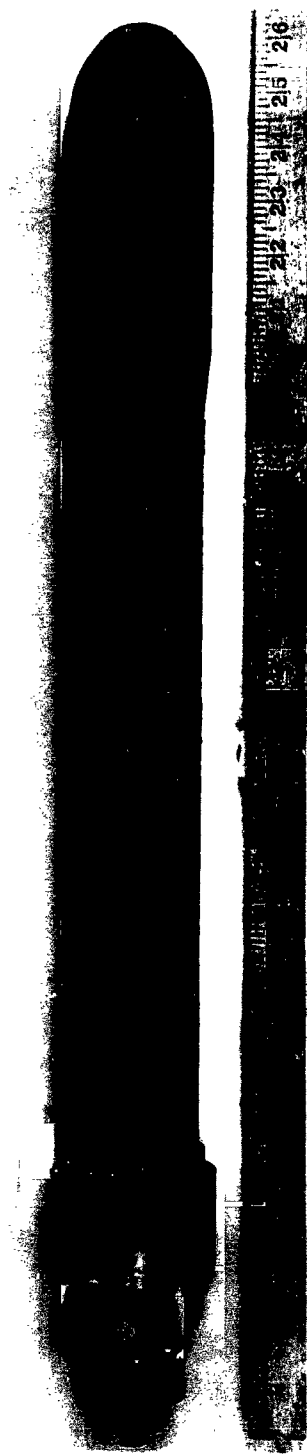
FIG. 8 HYDROPHONE NO. 2, CLEANED. SENSITIVE PORTION  
AT BOTTOM; REMAINDER IS A PRE-AMPLIFIER.

Description: Crystal unit approximately 4 inches long

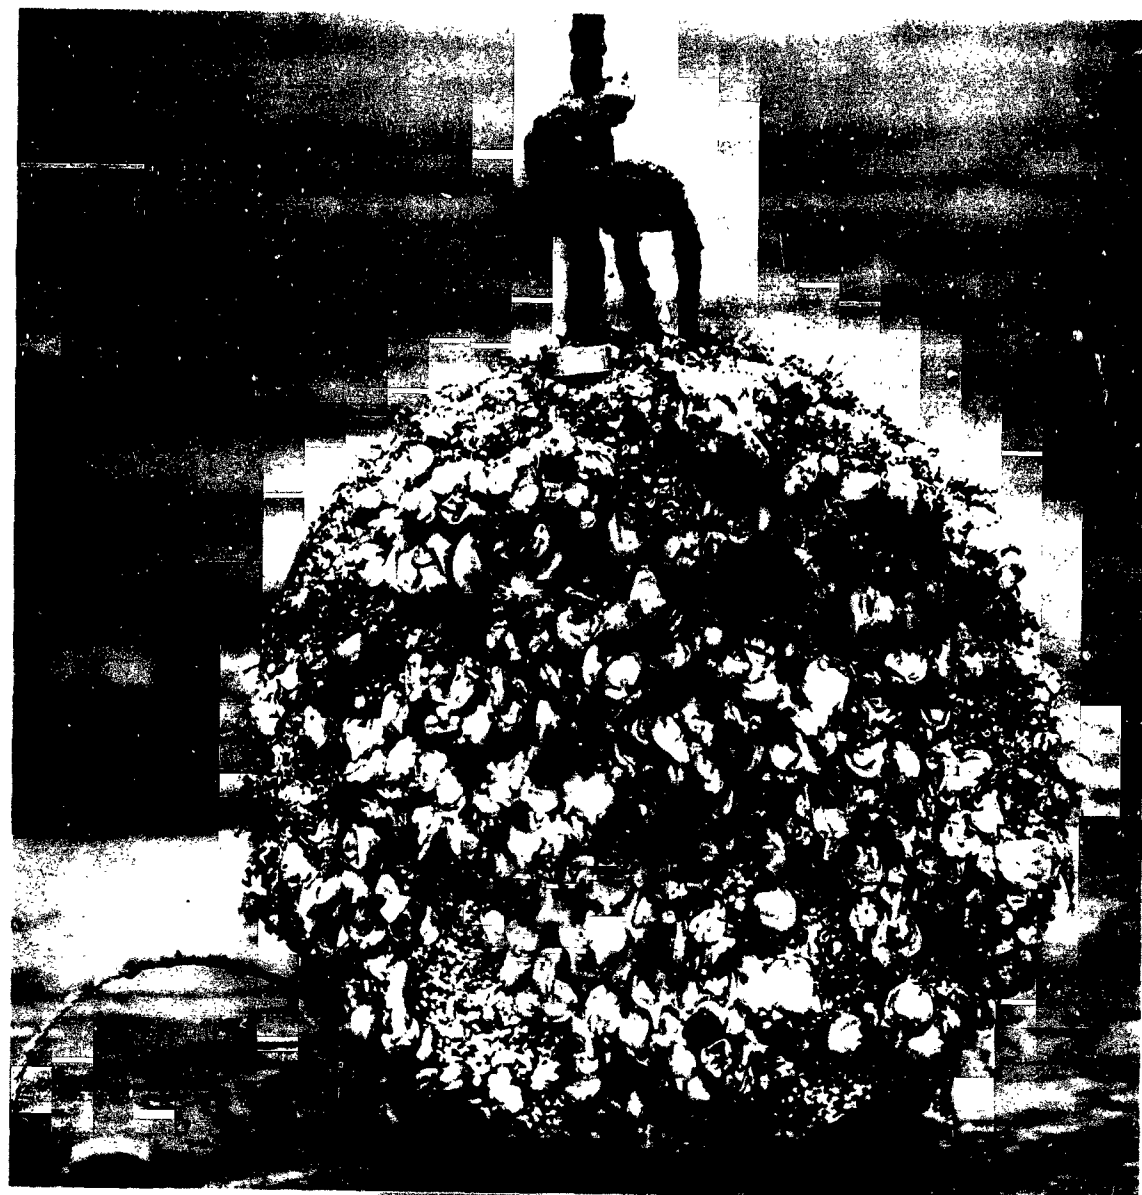
FIG. 12 HYDROPHONE NO. 3, FOULED

Description of Fouling: Face covered almost completely with small barnacles 5-6 mm diameter (*Balanus improvisus*), on top of which were large sea squirts. Large patches of dead barnacles are evident in the photograph.

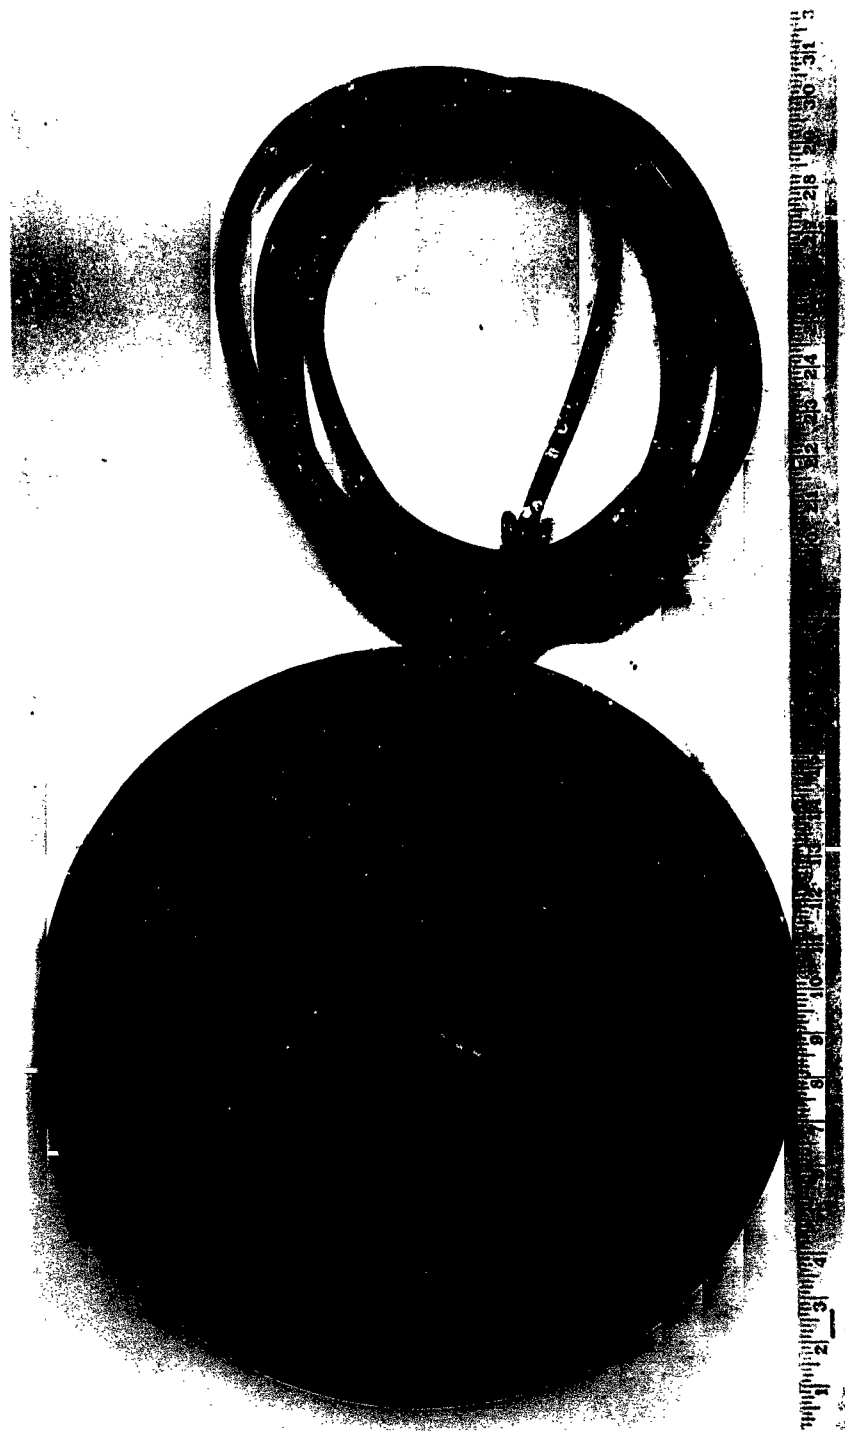
FIG. 13 HYDROPHONE NO. 3, CLEANED

Description: Flat faced crystal mosaic, tuned at 26 kc, diameter 13 inches.
